WIESE INDUSTRIES

APPLICATION BULLETIN

Wiese Industries is issuing a reminder to check the shanks on DMI/CNH rippers/subsoilers for excessive wear that may limit the features and benefits of Wiese replacement points.

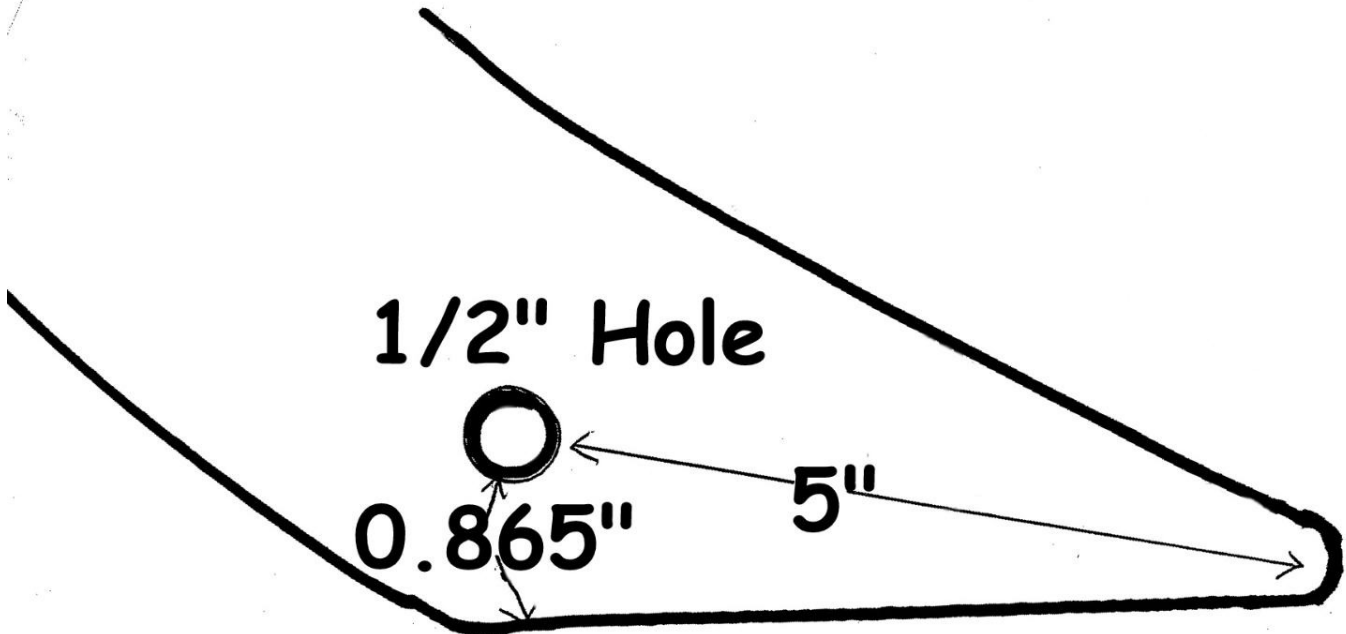
DMI 1-1/4" Subsoiler Shank

The OEM points for these machines used an open bottom mounting boot. This design exposes the bottom of the shank to wear that may allow the replacement point to rotate up and down.

This situation can cause difficulty in penetration, increase horsepower requirements, and result in premature point failure.

To ensure proper fit of Wiese replacement points, refer to Page 2 for approximate original shank dimensions. The shanks may require repair to return the worn areas back to the same size as a new shank. Replacement shanks may have to be installed if repair is not feasible.
